## Quick Fix Repair Kit

### A New Solution for Repairing Damaged Rubber Air Lines

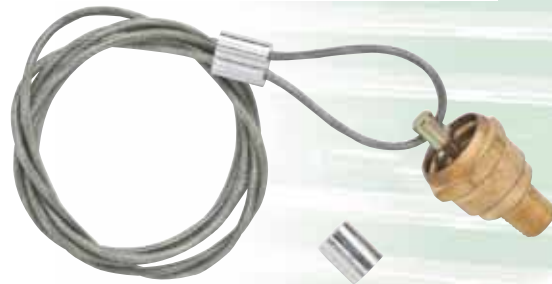
GT-5300

## Heavy Duty Drain Valve

- 60" cable with 1/4" pipe thread (includes brass valve and cable)  
Replaces Phillips Part No. 12-820
